QUINNIPIAC RIVER BASIN
HAMDEN, CONNECTICUT

LAKE WHITNEY DAM
CT 00119

PHASE I INSPECTION REPORT
NATIONAL DAM INSPECTION PROGRAM

AUGUST 1978

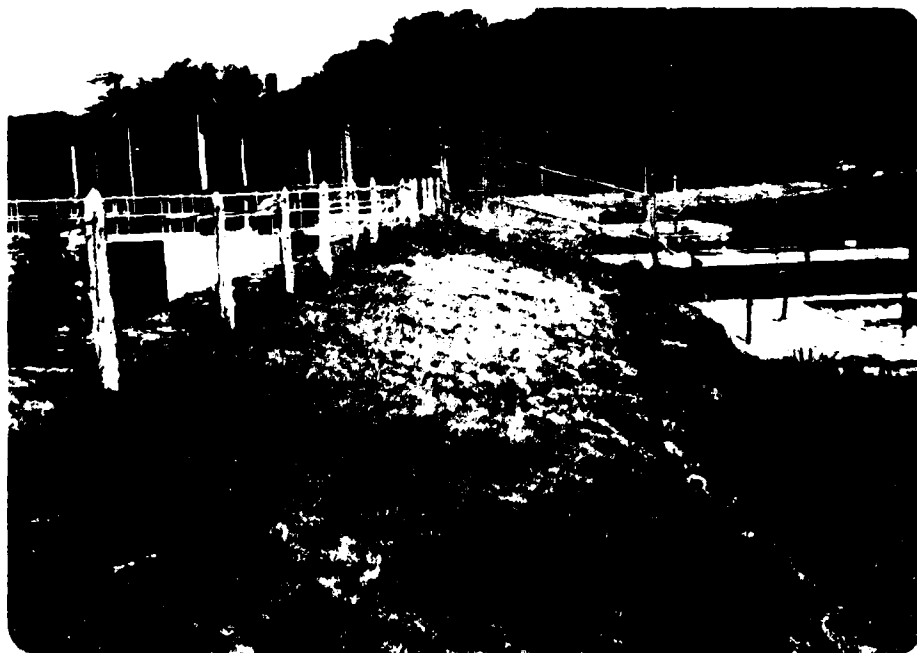
PHOTO NO.2 - General view of crest of dam to right of
spillway showing three intake structures.
